### Report of Testing

Objective : Testing of Corrosion Resistance of Electrical Parts  
by Salt Spray Technique

Sample : Electrical conduit fitting

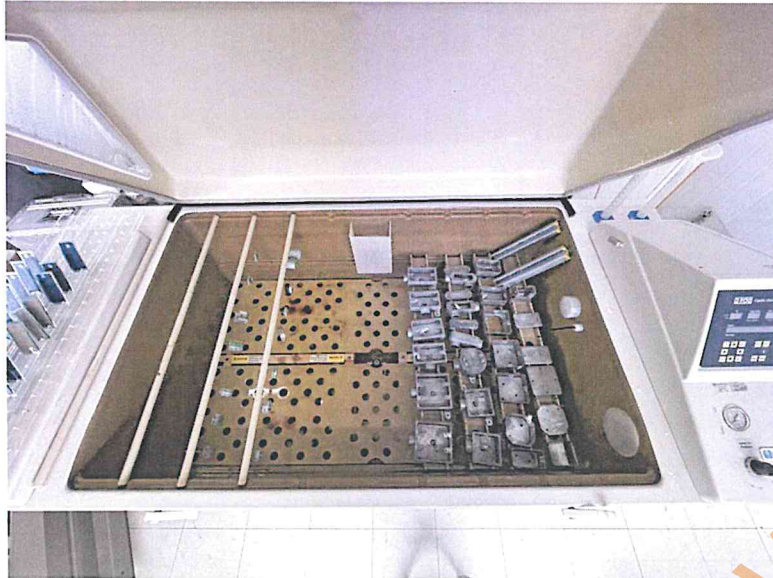
Fig. 1: Samples of electrical conduit fitting used to test corrosion resistance by the salt spray technique.

Therefore, the company has sent these products, as shown in Fig. 1, to the Smart Manufacturing and Maintenance Technology Research Team, the Rail and Modern Transports Technology Research Center (RMT), National Science and Technology Development Agency, which performed according to ISO 9227 standards for 24 hours to evaluate corrosion resistance using the salt spray technique in order to use the information to improve the design process and the production process for a longer lifespan.

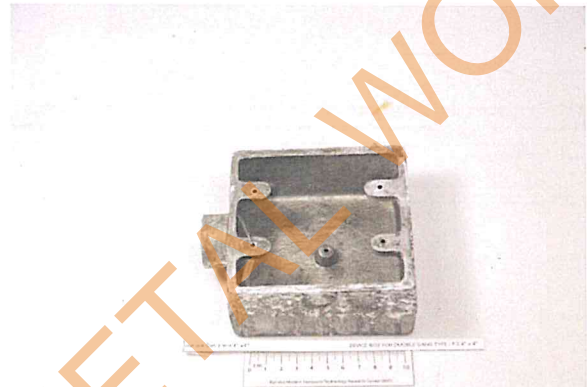
Fig. 2: DEVICE BOX FOR DUOBLE GANG TYPE – F.S 4"x4" before-after salt spray test.

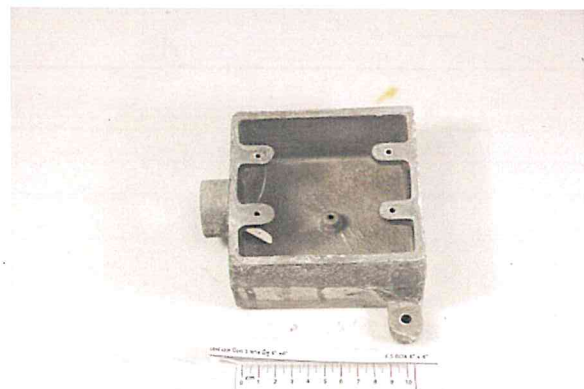
Fig. 3: F.S BOX 4"x4" before-after salt spray test.

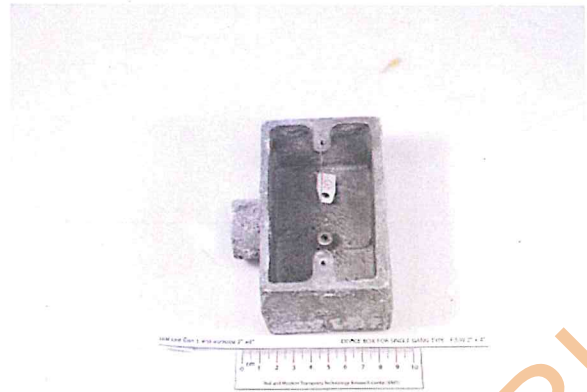
Fig. 4: DEVICE BOX FOR SINGLE GANG TYPE - F.S.W 2"x4" before-after salt spray test.

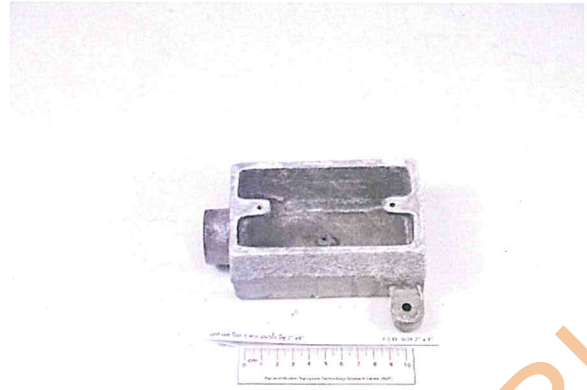
Fig. 7: F.S.W BOX 2"x4" before-after salt spray test.

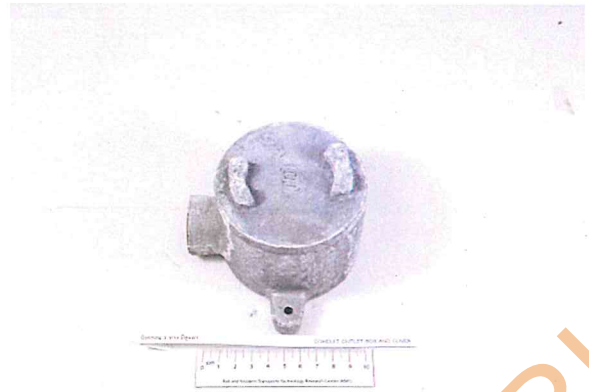
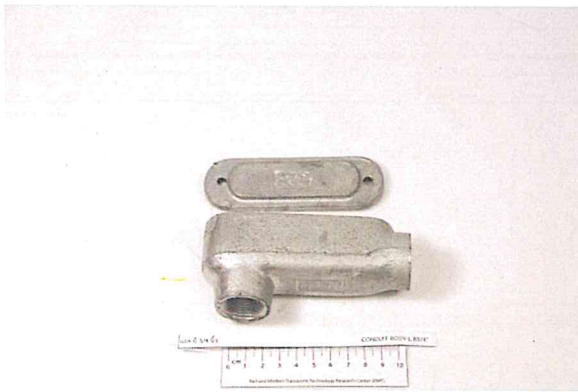
Fig. 10: CONDUIT OUTLET BOX AND COVER before-after salt spray test.

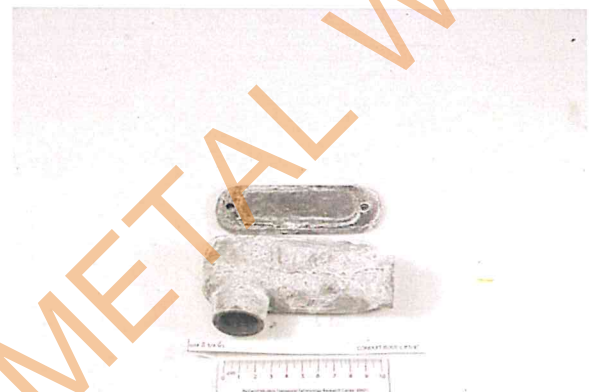
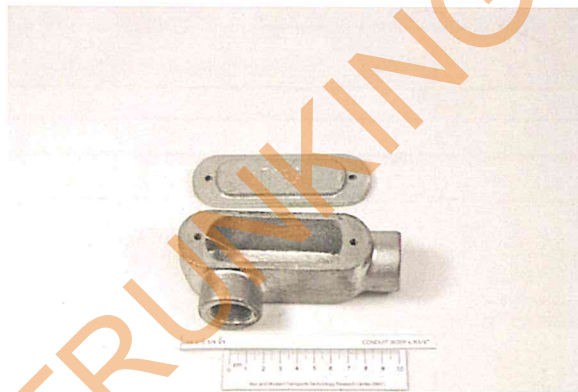
Fig. 11: CONDUIT BODY-L.B 3/4" before-after salt spray test.

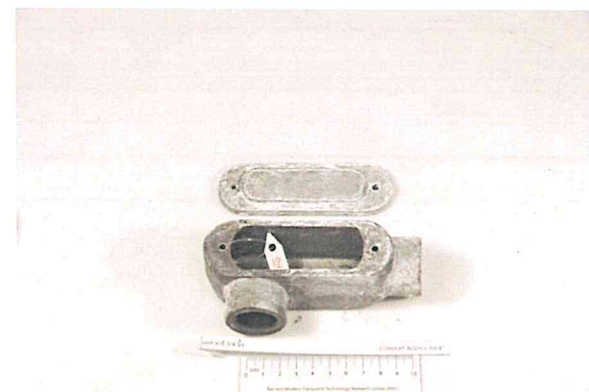
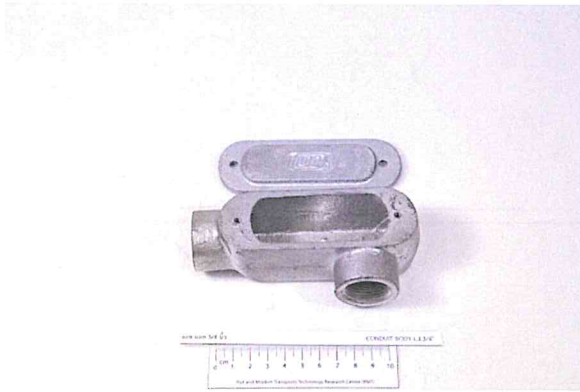
Fig. 12 CONDUIT BODY-L.R 3/4" before-after salt spray test.

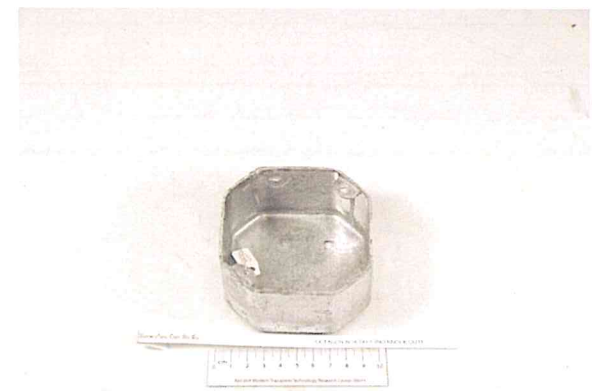
Fig. 15: OCTAGON BOX-DEEP (NO KNOCKOUT) before-after salt spray test.

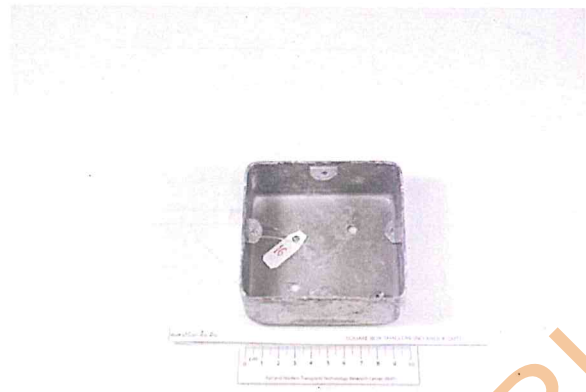
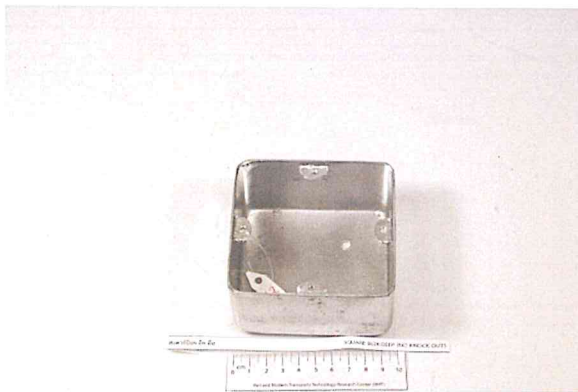
Fig. 16: SQUARE BOX-SHALLOW (NO KNOCKOUT) before-after salt spray test.

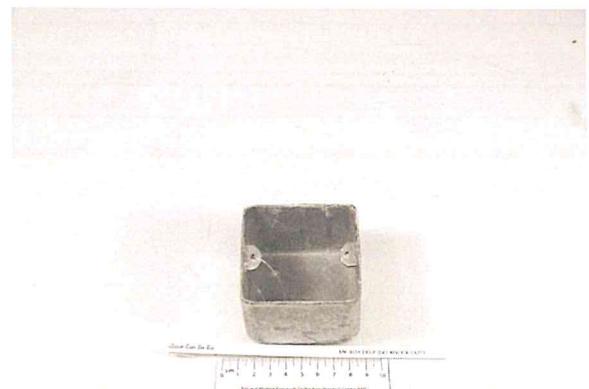
Fig. 21: MK BOX-DEEP (NO KNOCKOUT) before-after salt spray test.

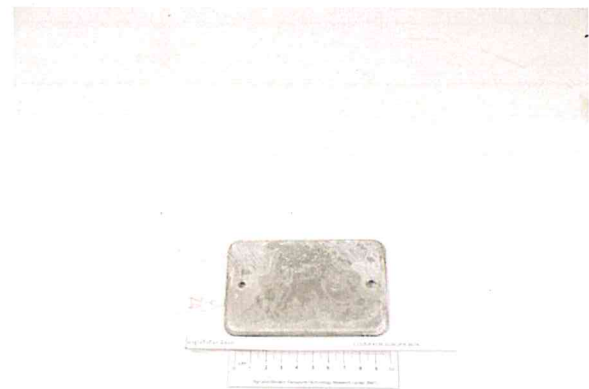
Fig. 24: COVER FOR EUROPA BOX before-after salt spray test.

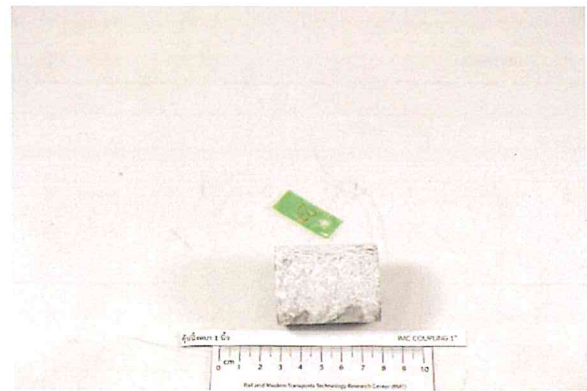
Fig. 27: IMC COUPLING 1" before-after salt spray test.

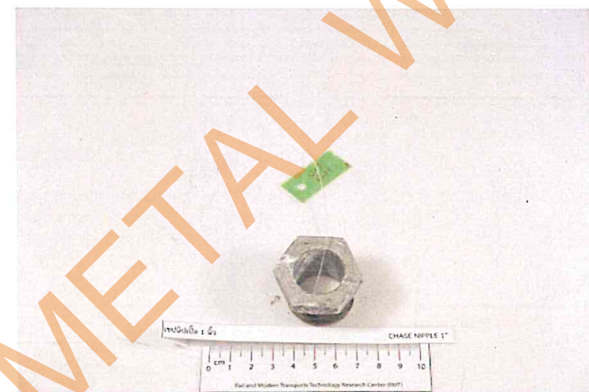
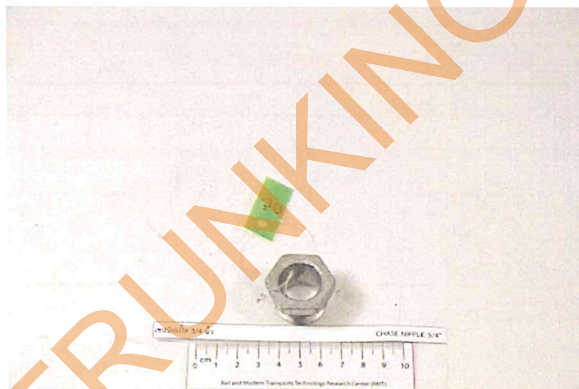
Fig. 29: CHASE NIPPLE 1" before-after salt spray test.

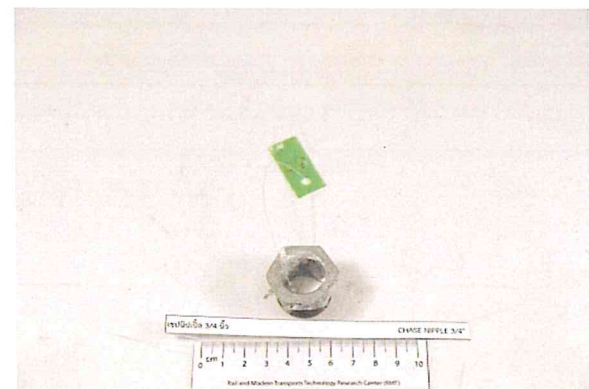
Fig. 30: CHASE NIPPLE 3/4" before-after salt spray test.

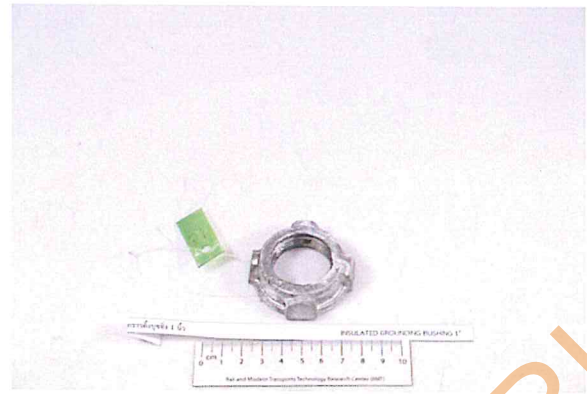
Fig. 31: INSULATED GROUNDING BUSHING 1" before-after salt spray test.

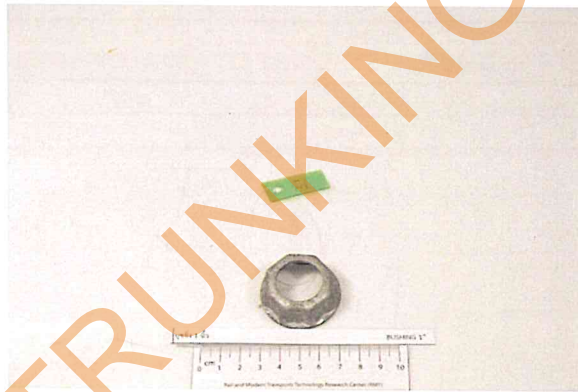
Fig. 32: INSULATED GROUNDING BUSHING ¾" before-after salt spray test.

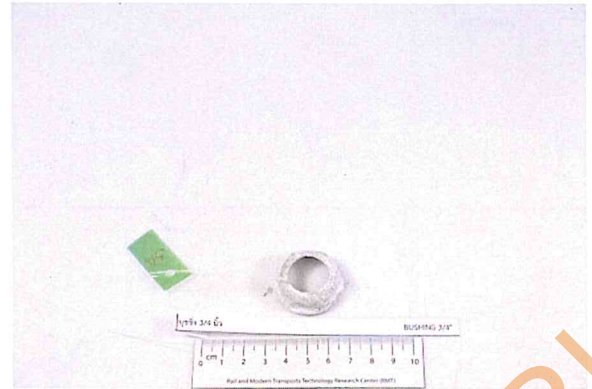
Fig. 34: BUSHING 3/4" before-after salt spray test.

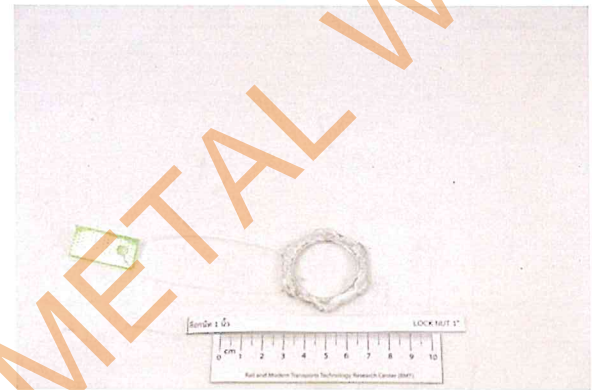
Fig. 35: LOCK NUT 1" before-after salt spray test.

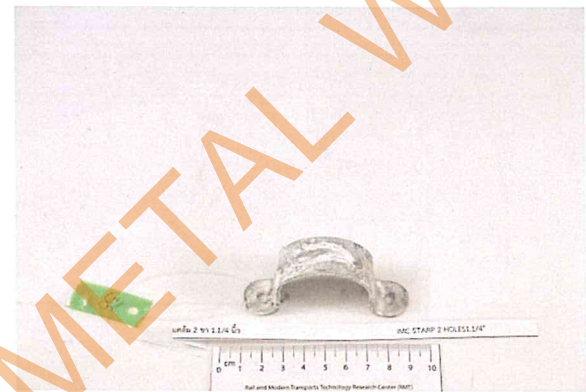
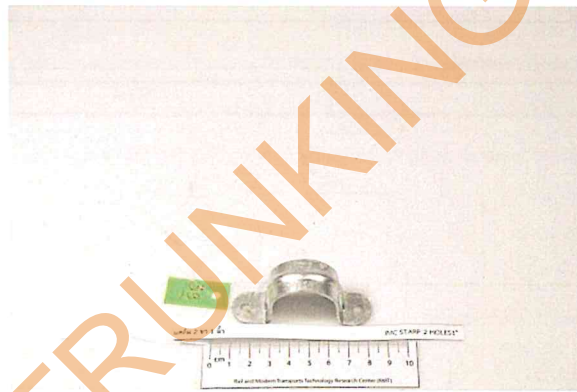
Fig. 38: IMC STARP 2 HOLES 1.75" before-after salt spray test.

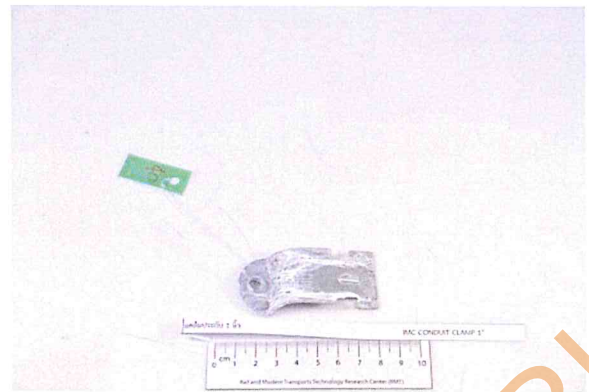
Fig. 40: IMC CONDUIT CLAMP 1" before-after salt spray test.
